ELEVATION CERTIFICATE

A2. Building Street Address (including Apt., Unit, Suite, and/or Bldg. No.) or P.O. Route and Box No. **3410 South Jamie Avenue**

A4. Building Use (e.g., Residential, Non-Residential, Addition, Accessory, etc.) **Accessory: Non-habitable Structure**

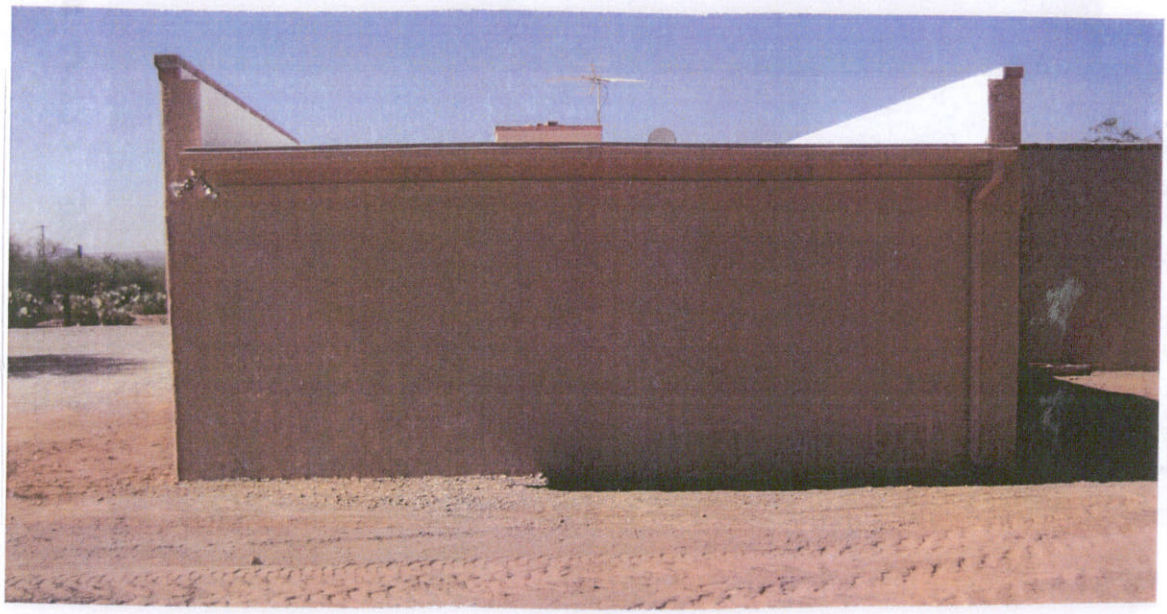
NORTH SIDE LOOKING SOUTH. 5/29/09

EAST SIDE LOOKING WEST. 5/29/09

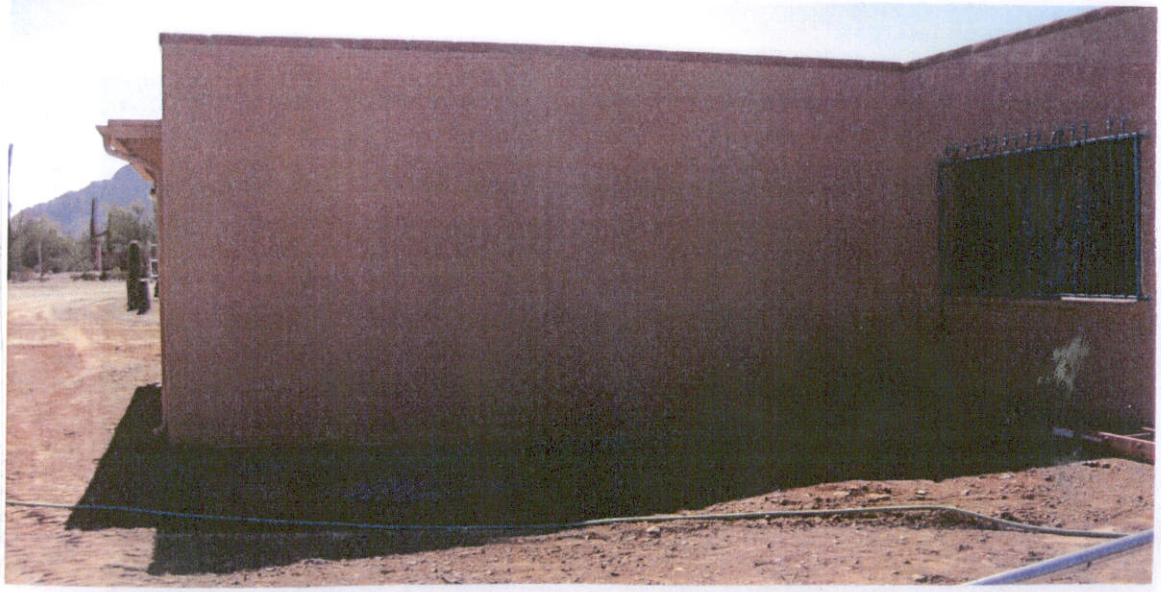
WEST SIDE LOOKING EAST. 5/29/09

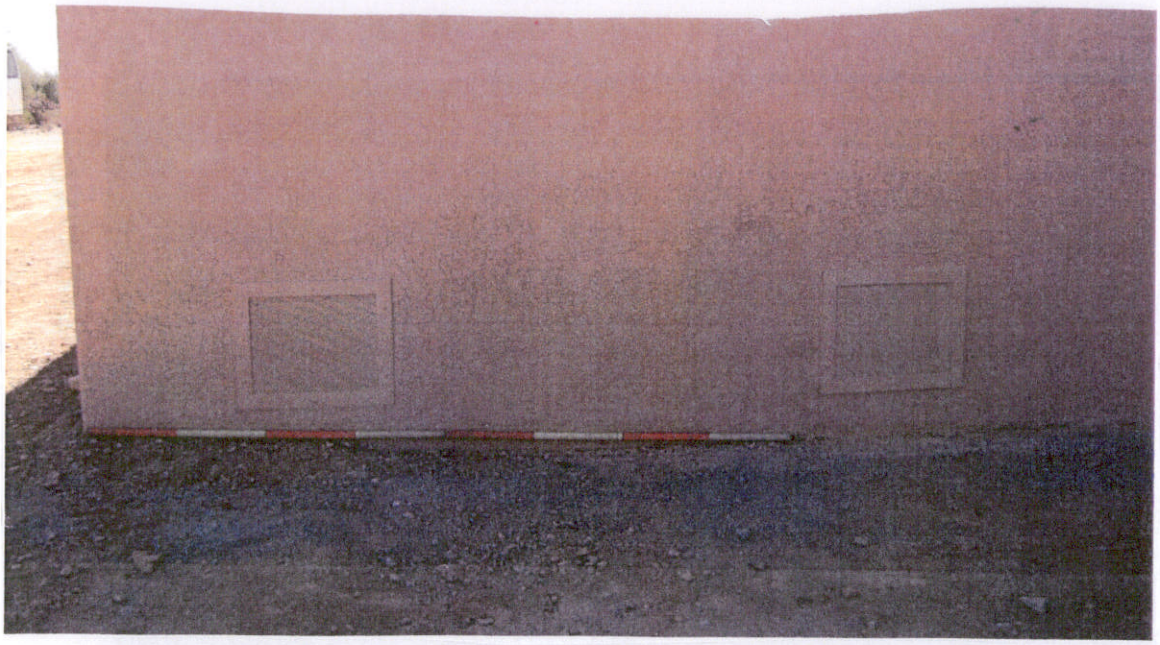
CLOSE-UP OF FLOOD VENTS ON WEST SIDE. 5/29/09

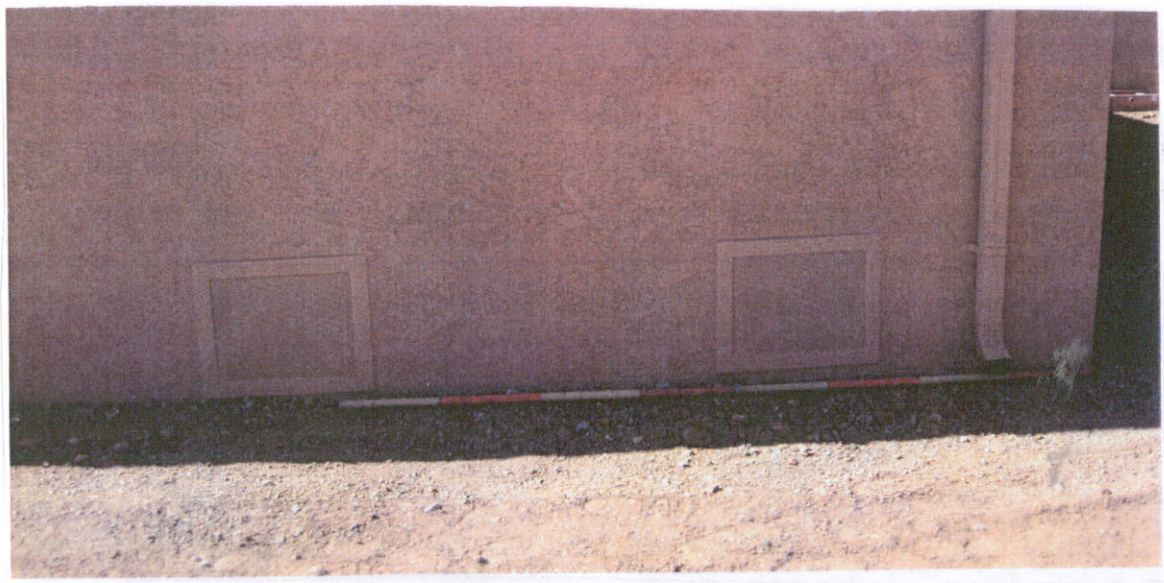
CLOSE-UP OF FLOOD VENTS ON NORTH SIDE. 5/29/09

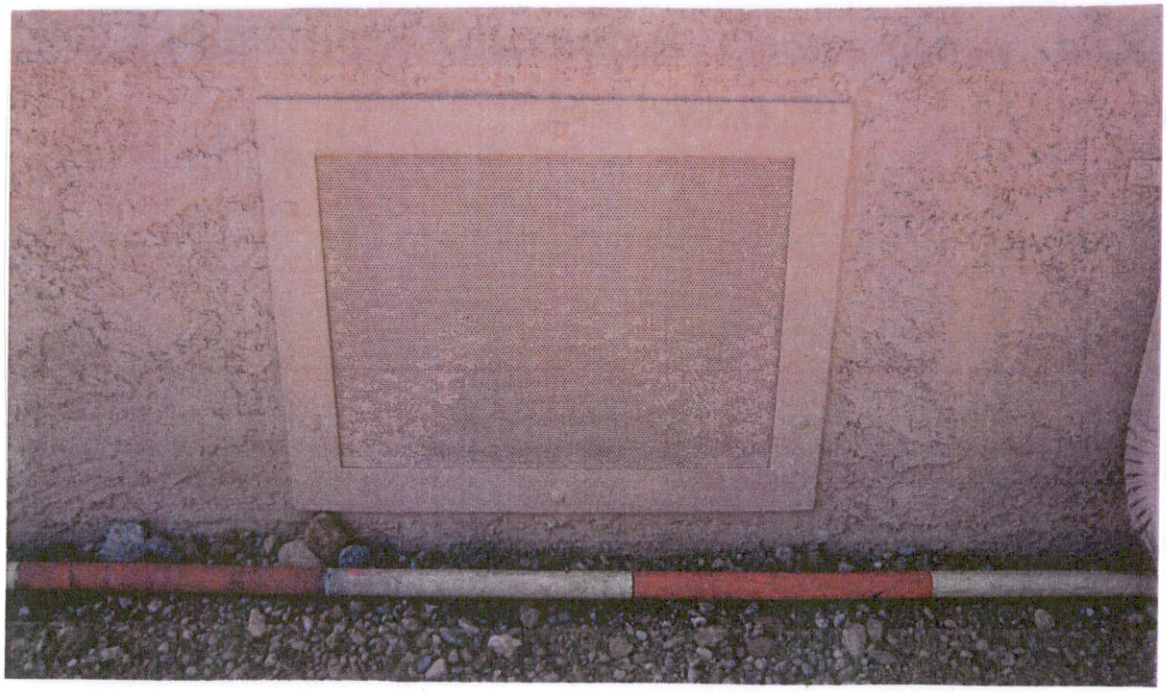
TYPICAL FLOOD VENT. 5/29/09

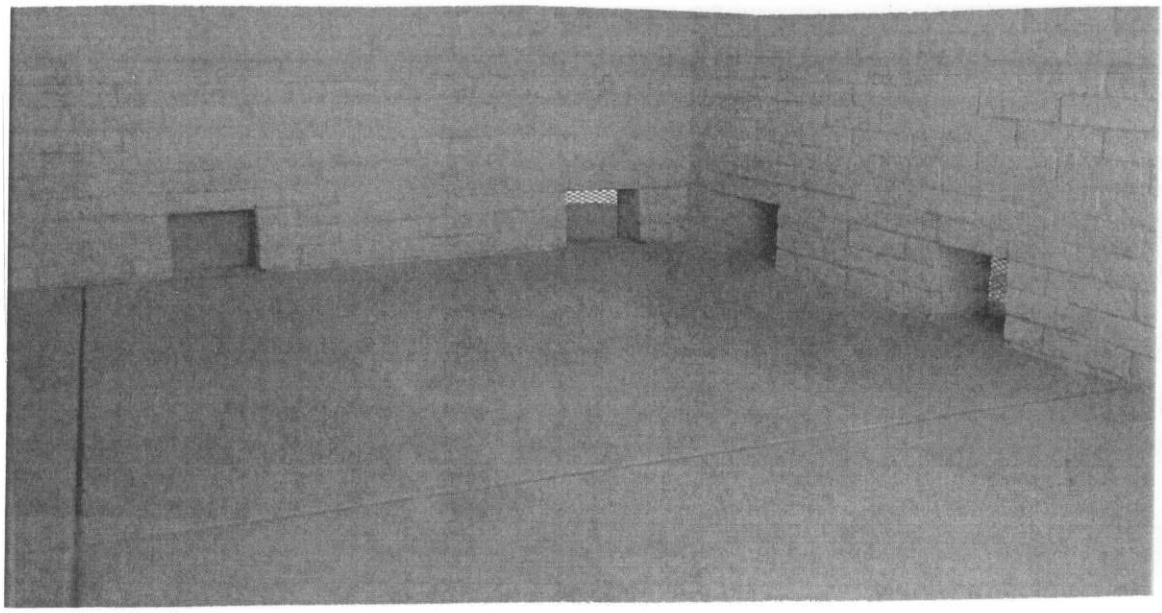
VIEW OF FLOOD VENTS LOOKING NORTHWEST FROM INSIDE OF GARAGE.
